SELECTED TECHNICAL ASPECTS OF TU-154M SMOLENSK AIR CRASH ON APRIL 10, 2010

JACEK F. GIERAS

ABSTRACT. This is a collection of reports that consists of three parts. The author is a Professor of Power Electrical Engineering, so he focuses on the Tu-154M power electric system and all aspects of the air crash that relate to electrical equipment and wiring.

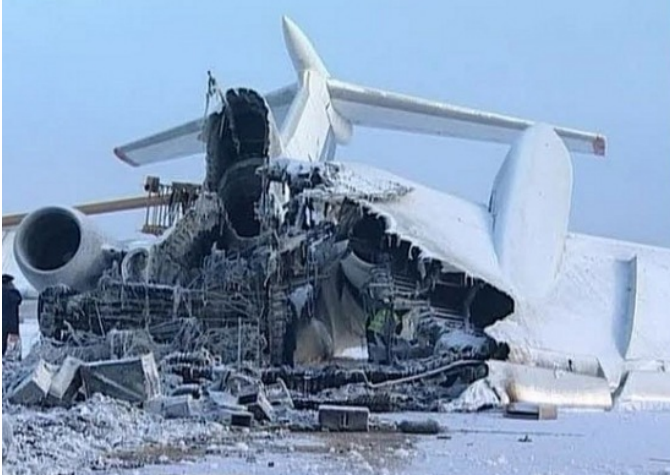
There is known at least one case of main generator failure, i.e., the Tu-154B2 RA-85588 while operating flight 7K 348 on January 1, 2011 from Surgut (located

Figure 1.12: Tail part of Tu-154B2 RA-85588 after fire at Surgut airport on January 1, 2011 [30].

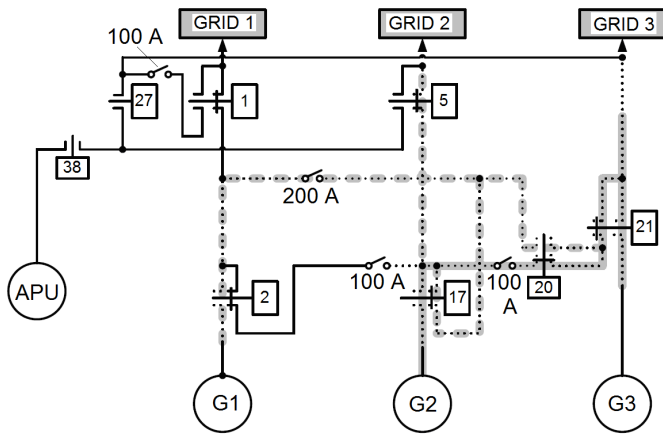
Figure 1.13: Closed electric circuit on assumption of abnormal scenario corresponding to the 21st contactor TKS233DOD “switching generator No 3 on grid” [30].

connected together instead of being connected to parallel busses (Fig. 1.13). Under such conditions the currents can reach more than 10 times the nominal current of the generator. The unsynchronized operation of the generators can be attributed to:

1. Poor technical conditions of contacts TKS233DOD (Fig. 1.13) responsible for connecting the generators with the electrical busses, that were damaged by prolonged operation without maintenance. A contact normally open was welded and fractured insulation material moved between contacts that are normally closed. These abnormal contact positions led to the connection between No 2 and No 3 generators (Fig. 1.13).
2. Differences in the schematic diagrams of generator No 2 and generators No 1 and 3. When the switch is moved from “check” to “enable” with no delay in the “neutral” position, the generator 2 is brought on line without time delay. This leads to increased wear of normally closed contacts in the TKS233DOD unit. The specific design of the electrical systems ensures power supply to each bus from either the APU or engine integrated drive generator.

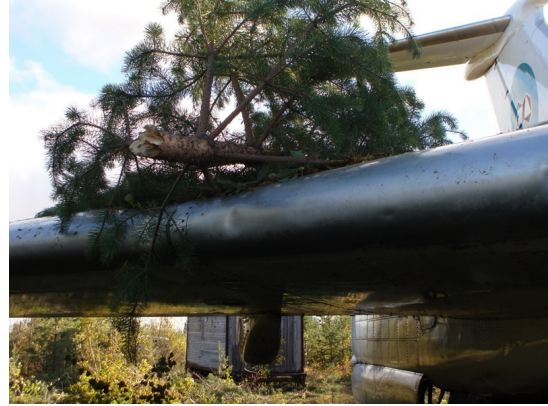
Figure 1.14: Emergency landing of the Tu-154M RA-85684 at abandoned air strip near town of Izhma on September 7, 2010. The impact was damped by the young trees which have grown since the airport was closed. The photograph shows the right wing that cut a pine tree [46].

On September 7, 2010, the Tu-154M RA-85684 Alrosa Mirny Air Enterprise Flight 514 aircraft from Udachny (located 1370 km northwest of Yakutsk on the Markha River) to Moscow suffered a complete electrical failure *en route*, leading to a loss of navigational systems. The electrically operated fuel transfer pumps were also affected and prevented transfer of fuel from the wing tanks to the engine supply tank in the fuselage.

After emergency descent below cloud level the crew were able to spot an abandoned air strip near town of Izhma (Fig. 1.14). The abandoned air strip is 1325m, whereas the Tu-154 requires a minimum of 2200 m. The aircraft landed at a speed of 350 to 380 km/h, faster than normal, due to the lack of flaps. Although the flaps are powered by hydraulics, the switches operating them are electrical. All 9 crew members and 72 passengers evacuated using the aircraft's evacuation slides. No injuries were reported.

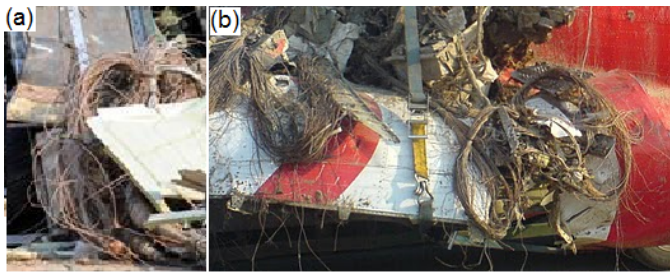
Figure 1.16: Electric wires scattered throughout the Tu-154M No 101 wreckage: (a) at the crash site (beside spare landing gear wheel); (b) hanging from heavy transportation vehicle.

There is no evidence that other than visual inspection of electrical equipment and wiring (Table 1.3) has been done on the crash site [13, 15]. The following statement is given on p. 20/28 of Annexure 4 [15]: *Bundles of electrical wires torn apart (Fig. 1.16). Control boxes deformed. Enclosures of on-board batteries deformed. Some cells leaking.* The report shows photographs of wire bundles, control boxes (Fig. 1.17), synchronous generator GT40PCh6 on the turbofan engine No 1 (Fig. 1.18), batteries and other electrical equipment.

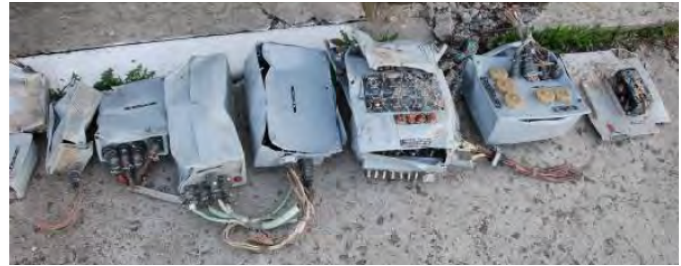
Figure 1.17: Junction and control boxes of electrical installation. Photo taken at the site of wreckage storage [16].

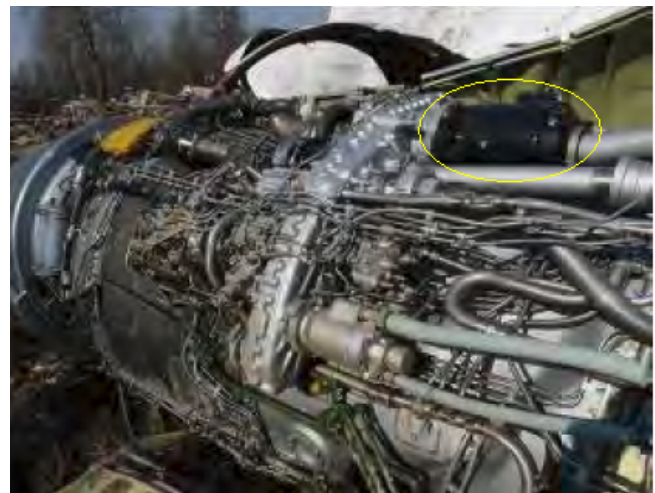
Figure 1.18: Generator GT40PCh6 on No 1 (left) D-30KU turbofan engine. Photo taken between 11 and 13 April 2010 on the crash site [15].

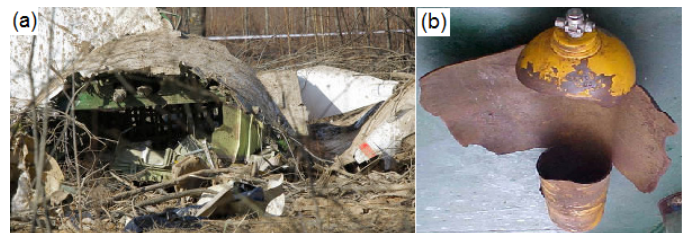
Figure 2.2: Comparison of the fuselage at the crash site on April 10, 2012 with burst gas cylinder: (a) the fuselage looks like burst from inside, the walls are split along its longitudinal axis and open to the outside (<http://krsk.sibnovosti.ru/incidents/103354-podrobnosti-krusheniya-tu-154-v-smolenskoy-oblasti>); (b) burst gas cylinder (http://www.scubaengineer.com/scuba_cylinder_videos.htm).

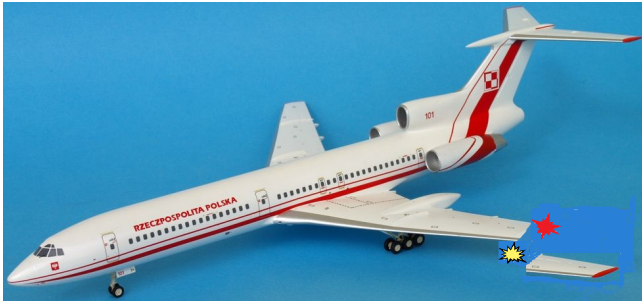
Figure 2.3: Hypothesis of explosion in the left wing.

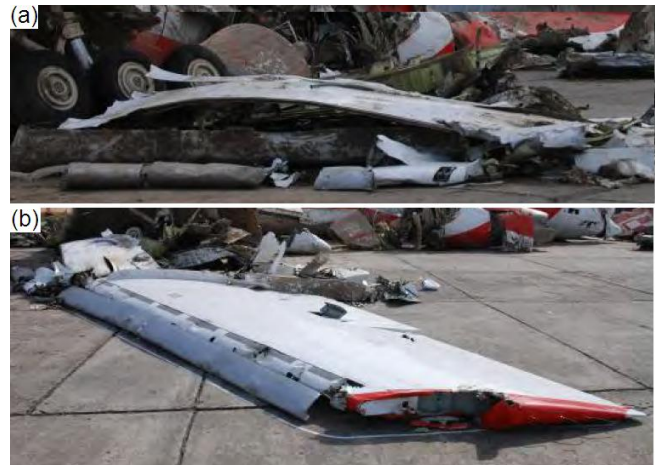
Figure 2.5: Left wing on the wreckage storage site: (a) effect of shock wave penetrating inside the wing [45]; (b) severed tip of the wing [16].

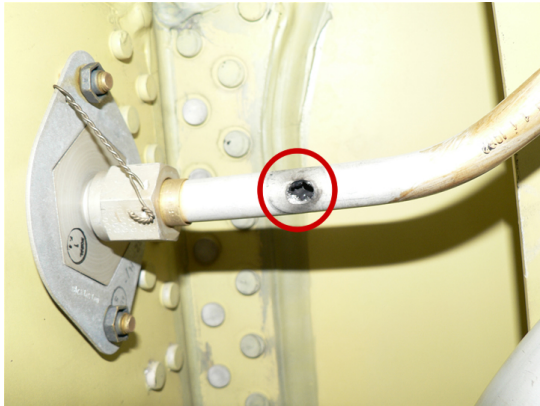
Figure 2.9: Evidence of electrical arcing of the wiring inside the exploded fuel tank of Boeing 727-200, Transmile Airlines, Bangalore, May 4, 2006 [51].

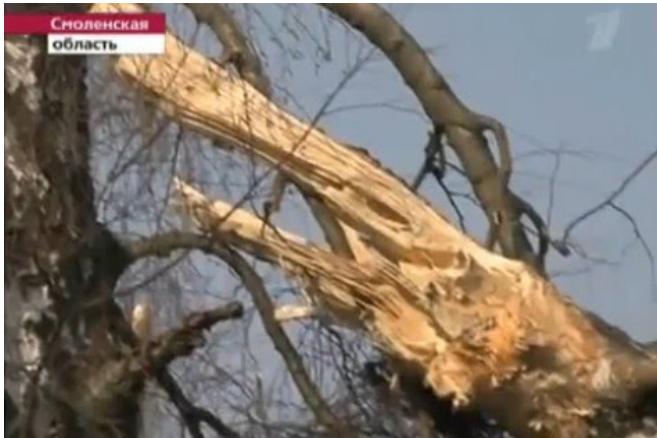
Figure 3.13: Fracture of the trunk of birch tree situated 855 m from the RWY26 runway threshold and 63 m to the left of the glide path. No piece of metal is visible. Photograph taken immediately after crash.

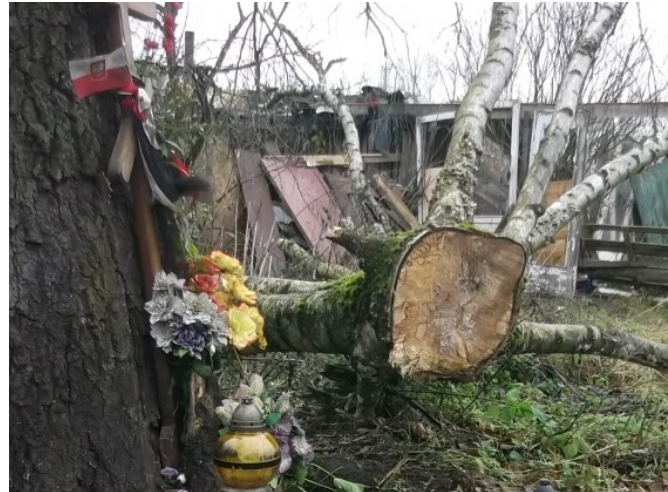
Figure 3.14: The part with fracture of the birch trunk was cut off probably in September 2012. Photograph uploaded on November 14, 2012. Source: <http://imgsrc.ru/para-moto1/30127119.html>.

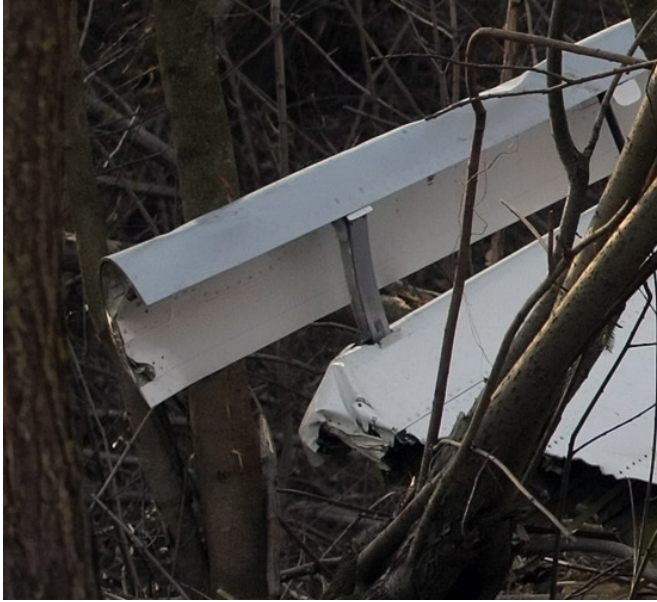
Figure 3.15: Tip of the left wing of the Tu154M No 101 after air crash. The main body of the wing has been cut off while the slat is intact.
