SELECTED TECHNICAL ASPECTS OF TU-154M SMOLENSK AIR CRASH ON APRIL 10, 2010

JACEK F. GIERAS

ABSTRACT. This is a collection of reports that consists of three parts. The author is a Professor of Power Electrical Engineering, so he focuses on the Tu-154M power electric system and all aspects of the air crash that relate to electrical equipment and wiring.

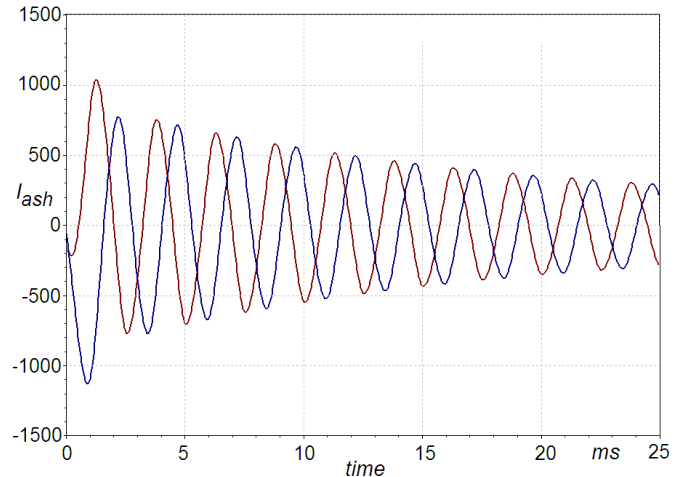
Figure 1.11: Armature current I_{ash} at two lines-to-neutral short circuit of GT40PCh6 synchronous generator. The peak short-circuit current is $I_{ashp} = -1130$ A corresponds to $t = 0.6$ ms [20].

Short-circuit currents can exceed more than 11 times the nominal current. The most dangerous is two lines-to-neutral short circuit (Fig. 1.11).

In the report [30] there is no evidence that the short circuit current (Fig 1.11) under unsynchronized operation has been calculated including actual conditions during the incident. It was rather estimated on the basis of engineering practice or obtained from the manufacturer of generators.

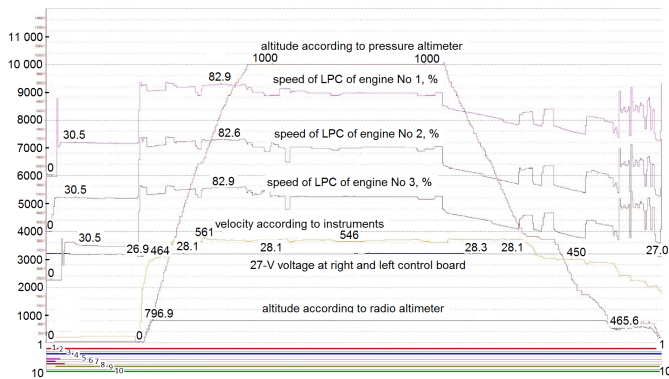
Figure 1.15: Parameters of flight of the Tu-154M No 101 for electrical equipment and engines on April 10, 2010, 7:14 – 8:41 am. LPC = low pressure compressor. Description in Table 1.4 [14, 15].

Operation of electrical equipment and installation of the Tu-154M is monitored by the MSRP² flight data catastrophic recorder with the aid of parameters described in Table 1.4. Those parameters are plotted in Fig. 1.15 (color lines at the bottom).

Credibility of flight parameters for electrical equipment and installation (Fig. 1.15) is questionable. There

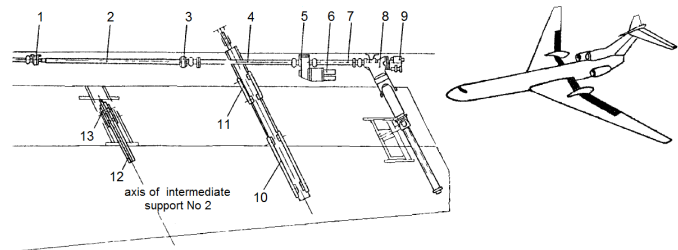
Figure 1.20: Location of electromagnetic brake TEM-4 for flap control. 1,3 – bracket, 2,4 – transmission shaft, 5 – reducer, 6 – electromagnetic brake TEM-4, 7 – cardan joint, 8 – lift for the outer flap, 9 – mechanism of limit switches with sensor, 10 – rail of external deflector, 11 – carriage of external deflector, 12 – rail of deflector, 13 – intermediate carriage of deflector [48].

The object found at the crash site several meters behind the famous “armored” birch tree [13] and shown in Fig. 1.19 has been often incorrectly identified as a fuel pump. However, this is the electromagnetic brake TEM-4 used for control of flaps (Fig. 1.20).

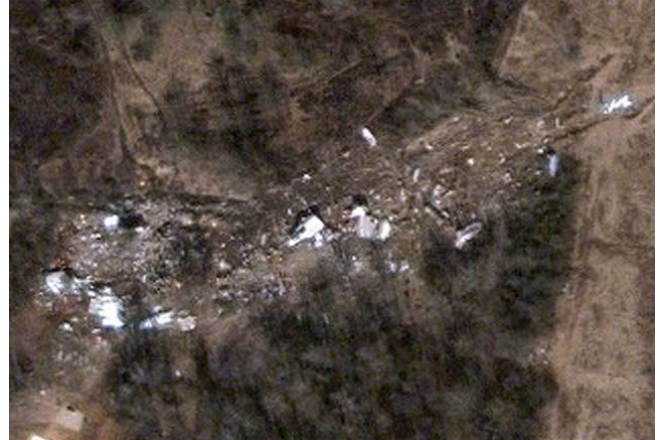
Figure 2.1: Plane crash site on April 12, 2012. Source: Global Digital.

According to official investigations of the Smolensk air crash [13, 29], the cause of disaster was collision of the Tu-154M No 101 with trees while landing in dense fog. At the distance of 855 m before the threshold of runway and 63-m left from its center line, the left wing of the aircraft hit a birch tree with the trunk diameter of about 0.4 m at the height of about 6.6 m [9]. As a result, the tip of the left wing of 6.1-m long between the 27th and 28th rib has been severed. The first ground impact was 525 m before the threshold of the runway and 105-m left from its center line. The satellite photograph of the crash site is shown in Fig. 2.1. Distribution, scattering and shape of debris, characteristic opening of the

It is unlikely that the Tu-154M No 10 was smashed into small pieces scattered over large area (Fig. 2.1) as a result of mechanical impact to ground.

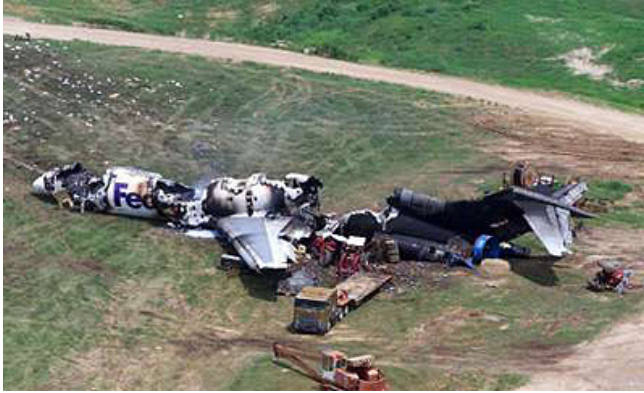
Figure 2.6: Wreckage of the Boeing 727-232F FedEx flight 1478 at Tallahassee Regional Airport (TLH). Source: <http://www.aero-news.net/images/content/commair/2003/fedex727crash07>

1478, a Boeing 727-232F, N497FE, struck trees on short final approach and crashed short of runway 9. The airplane collided with trees in a right-wing-low, slightly nose-up attitude during the approach to runway 9, then impacted the ground, coming to rest on a heading of 260° about 474 m (1556 feet) west-southwest of the runway (Fig. 2.6). A postimpact fire ensued; however, the three flight crewmembers exited the airplane through the captain's side sliding cockpit window before the fire reached the cockpit [12]. The crash site shown in Fig. 2.6 cannot be compared to that shown in Figs 2.1 and 2.2a. The Tu-154M is conceptually similar to the Boeing 727, e.g., both aircraft use a rear engine T-tail configuration, S-duct for the middle (No 2) engine, similar leading edge sweep of wings, etc.

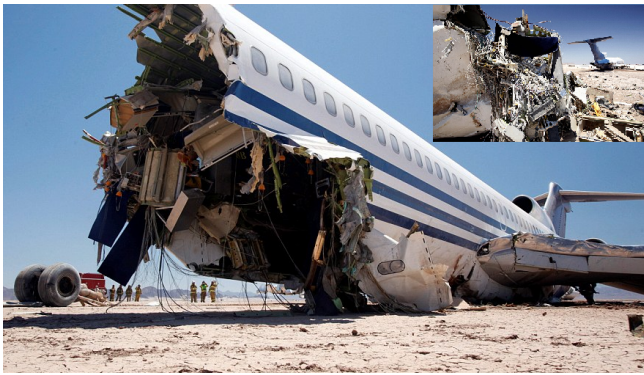
Figure 2.7: Boeing 727 after crash on Sonoran Desert with its fuselage ripped in two [47]. Compare with Fig. 2.1 .

Sonoran Desert of Baja California, Mexico, has shown no fragmentation of the aircraft into small pieces under ground impact (Fig. 2.7) [47]. The objective was to recreate a serious passenger jet crash landing, so that scientist and engineers could study the impact of air crashes on the human body and aircraft structure. The pilot parachuted out of the cockpit at 762 m before the plane was plunged into the ground via remote-control by a pilot in a following Cessna. As the plane hit the ground with its speed of 225 km/h, the fuselage was torn in two with the nose embedded in the ground. Crash investigators predicted that 78% of passengers on board would have survived such ground impact. The TU-154M is a Russian copy of Boeing 727.

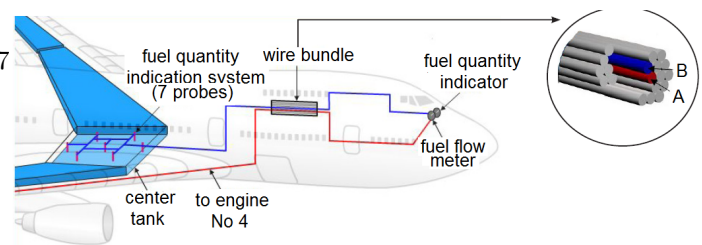
Figure 2.8: Wiring configuration on the Boeing 747. Investigators suspect that high voltage from the fuel flow meter A passed to the fuel quantity indication system (FQIS) B because of a short circuit in the wire bundle [34].

In older (and also many new) types of passenger aircraft the electric wires belonging to different electric circuits are laid in common bundles [18, 53]. It is economical solution, which reduces the cost of electrical wiring. On the other hand, aging and deterioration of insulation, wire overheating, short circuit or electric arcing in one electric circuit can make damage to insulation and short circuit of wires belonging to other electric circuits. Thermal protections are sometimes not reliable. For example, short circuit in a bundle of electric wires caused ignition of fuel-air mixture in the center wing tank (CWT) of the Boeing 747-131, flight TWA 800 on June 17, 1996 (Fig. 2.8). Burst of CWT led to destruction of the aircraft over the Atlantic Ocean [34].

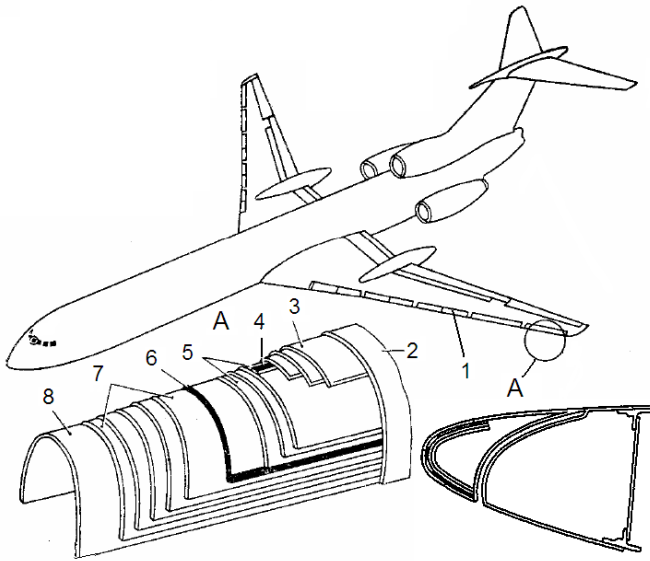
Figure 2.13: Leading edge wing anti-ice system: 1 – slat, 2 – outer skin/sheathing, 3, 5, 7 – thermal glass insulation, 4 – thermal “knife” (NiCr foil), 6 – heating element (composites), 8 – inner skin/sheathing [44, 52].

Malfunction of anti-ice electric heating system installed in slats (Fig. 2.13) could lead to local temperature rise in the tank wall and create friendly conditions for fuel ignition by sparks or arcing. Fuel vapor *auto-ignition* due to local hot spot in fuel tank, or temperature rise due to malfunction of anti-ice electric system or other electrical equipment/wiring is rather impossible, since the auto-ignition temperature of Jet A-1 fuel is 210°C (Table 2.3). More realistic is *electrostatic charge build-up* (ECA) due to fuel flow and hazardous electric potential level inside the tank.

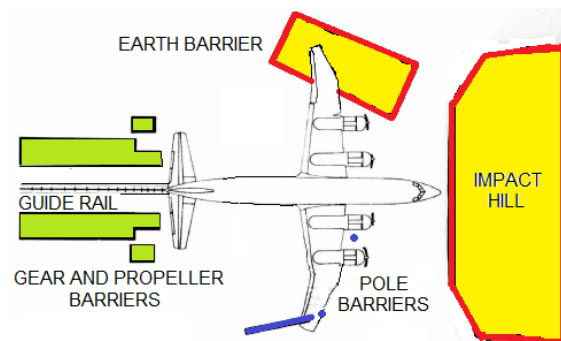
Figure 3.1: DC-7 test site and wing impact sequence. Telephone poles have been marked with blue color [40].

The test site has been designed in such a way as to obtain the desired impact conditions for accelerating the test aircraft to approximately the climbout velocity, controlled guidance of the aircraft to the initial impact point, and appropriate location of earthen barriers and telephone poles (Fig. 3.1).

wings, respectively [40, 41]. The left wing earthen barrier was a 4.57-m high inclined earthen mound with the face sloped 35° (Fig. 3.1). The right wing pole barriers (Figs 3.2 and 3.3) were made of standard 0.305-m diameter telephone poles (southern yellow pine) buried approximately 1.22 m in the ground [40, 41]. The earthen impact hill located behind the wing barriers (Fig. 3.1) was an 8° slope extending for approximately 38 m along the main axis of the test site [40, 41].

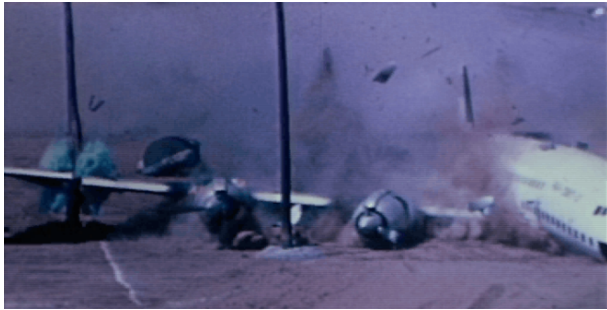
Figure 3.2: LC-1649 full-scale dynamic crash test. Out-board pole impact [41].

the second pole barrier, which crushed the wing leading edge structure back to the forward spar [41]. Then, the second pole broke [40]. The left wing tip after touching the earthen wing barrier suffered only a slight flattening [40].

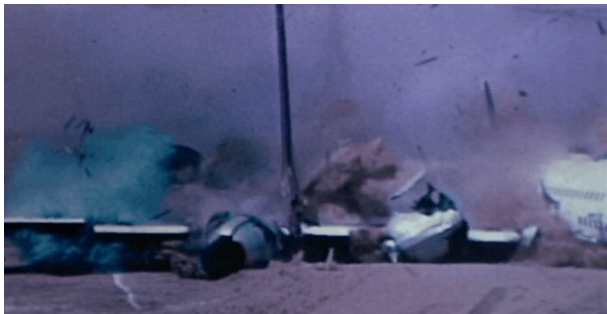
Figure 3.3: LC-1649 full-scale dynamic crash test. In-board pole impact [41].

- The aircraft hit the second inner pole approximately 0.15 s after the first pole impact. The inner pole struck the right wing between engines No 3 and No 4 (Fig. 3.11). The wing leading edge structure back to the forward spar was crushed. Then, the inner pole broke.

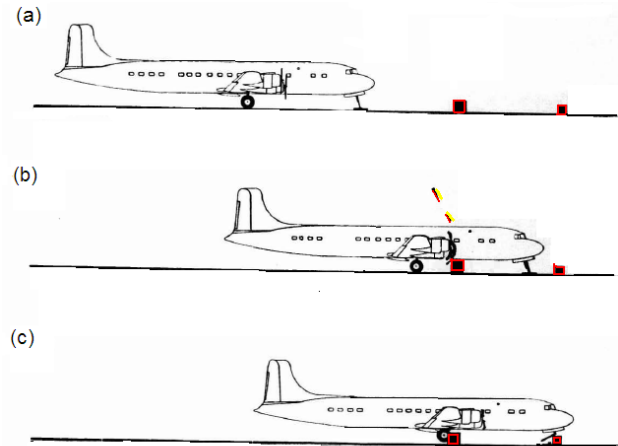
- The first barrier was the landing gear barrier (Fig. 3.10a).
- All four propellers were broken as a result of hitting the propeller barriers (Fig. 3.13b). All four engine mounts failed.
- The gear barrier torn out the right main landing gear, which struck the right horizontal stabilizer (Fig. 3.10c).
- The impact with the outer pole (Fig. 3.1) cut off the right wing approximately 3.66 m (12 feet) from the tip. The main tank No 4 (Fig. 3.11) was ruptured by the pole.

- The left landing gear was broken (Fig. 3.10) and caused the engine No 2 (Fig. 3.12) to roll under the left wing.
- The right landing gear was also broken and severed the right vertical fin of the right horizontal stabilizer.

Figure 3.10: Gear and propeller impact sequence: (a) aircraft approaching gear and propeller barriers; (b) impact with propeller barrier; (c) impact with main and nose landing gear barrier [40].

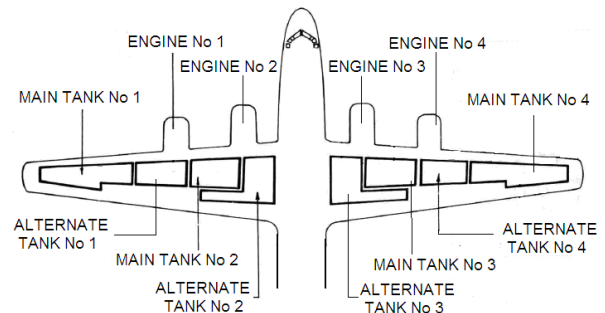
Figure 3.11: DC-7 fuel tank and engine locations [40].

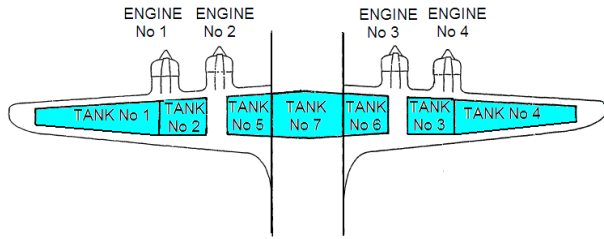
- The propeller of the engine No 2 (Fig. 3.12) was sheared off by the landing gear barrier.
- The engines No 1, 3, and 4 (Fig. 3.12) and their propellers were intact, with the exception of one propeller blade of the engine No 3, which was sheared off by the right main gear barrier (Fig. 3.10).

- The rail guide shoe was broken off on impact with the nose gear barrier (Fig. 3.10c). The gear strut was forced into the forward fuselage.
- After passing through the gear barriers and hitting the earth, propellers on engines No 1, 3, and 4 (Fig. 3.12) lost their blades. A tear in the wing structure adjacent to the engine nacelles became visible.

- The left wing struck the earthen barrier and started to separate from the fuselage at the wing root, while the right wing hit the poles.
- The first pole nearly sheared off the outer panel of the right wing and opened up the fuel tank No 4 (Fig. 3.12) about 7.6 m (25 feet) from the tip (Fig. 3.2). The second pole cut into the wing and the No 3 fuel tank between the engines No 3 and No 4 (Fig. 3.12). The portion of the right wing inboard of the No 3 engine nacelle remained attached to the fuselage throughout the crash (Fig. 3.3).

Figure 3.12: LC-1649 fuel tank and engine locations [41].
